## [NM-297] Second Degree Burns After MRI

Bhattacharya S

Mgh , Swampscott , MA, USA

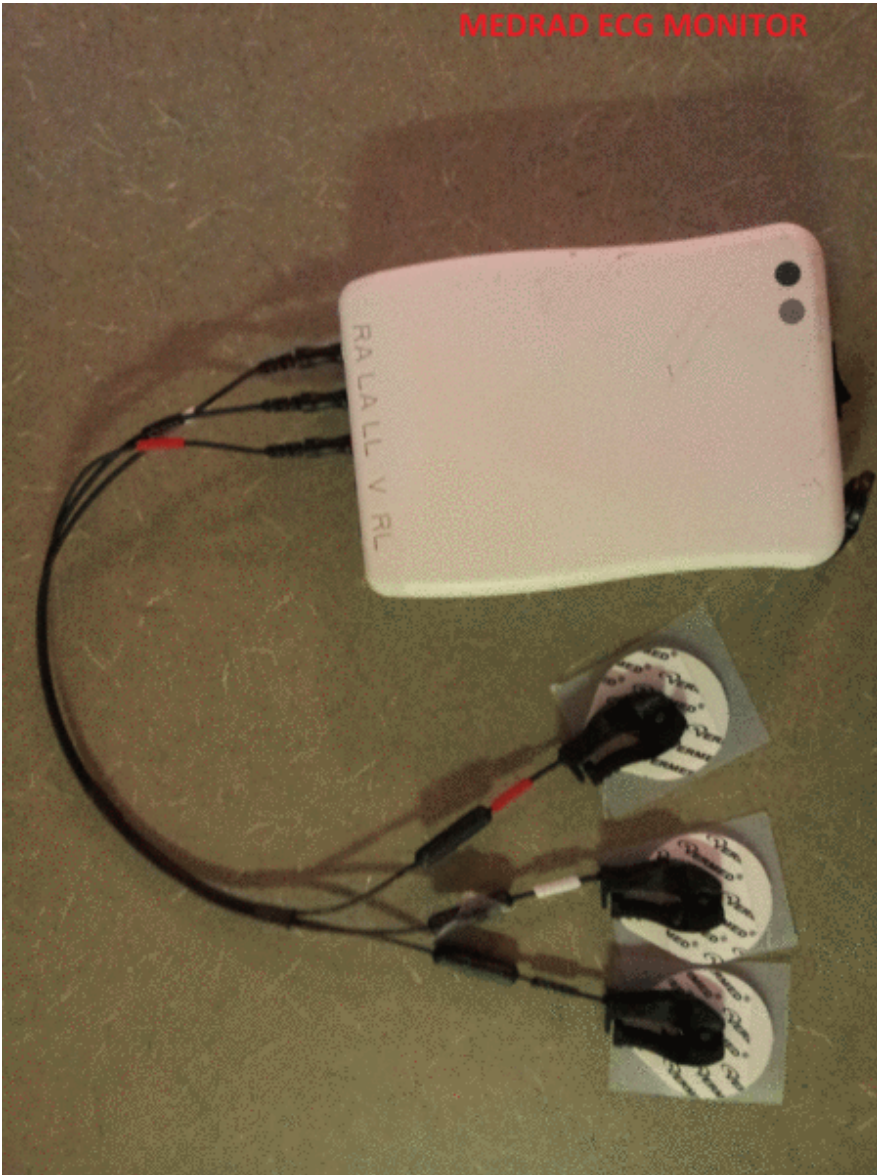
MEDRAD ECG MONITOR

The ECG monitor used was MEDRAD Veris( Model 8600)Fig 1. At the end of imaging, an unusual redness was noticed on removal of the ECG leads. Blisters were noticed 30 minutes later in recovery when patient started complaining of itching at the site. He was diagnosed with second degree burns and treated accordingly. Pictures were taken on the day and a week after the incident.(figures 2 &3)

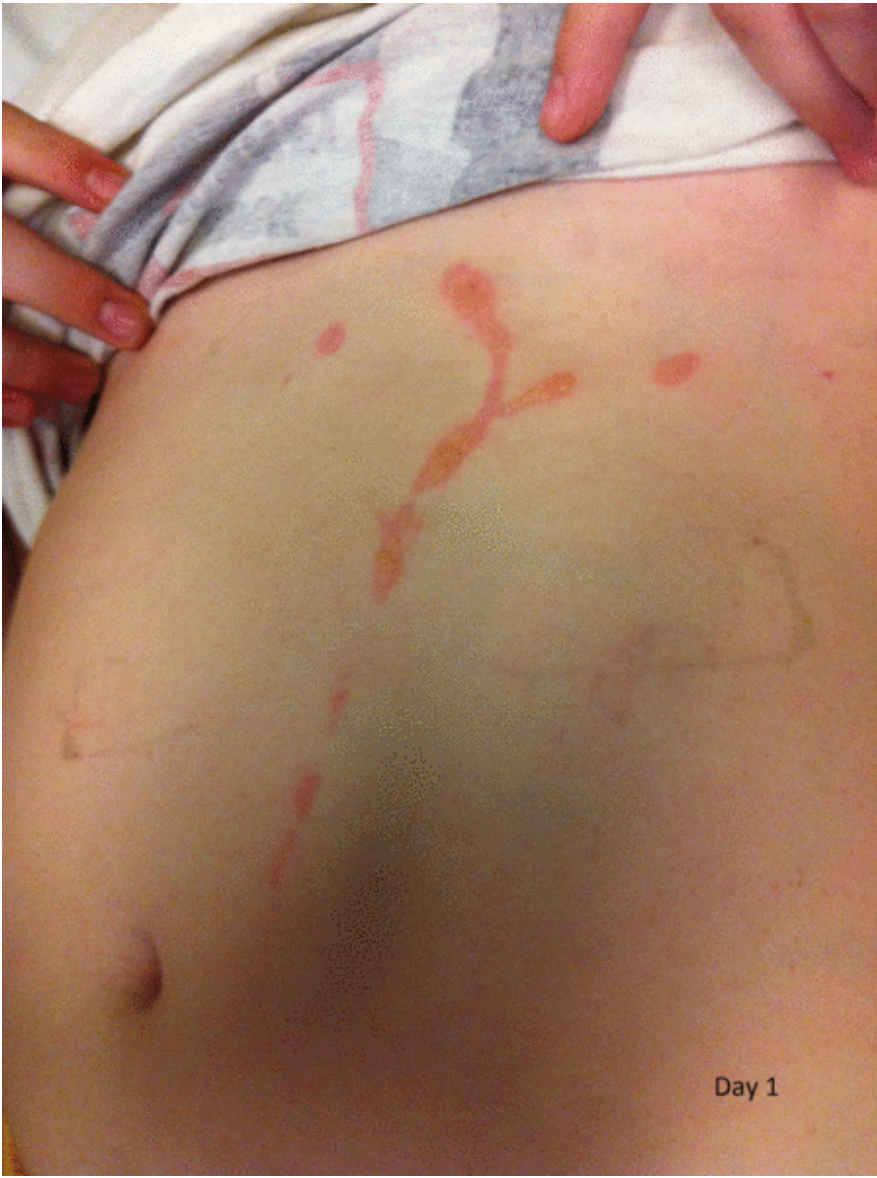
Day 1

1. Formation of a loop in the ECG cable
2. Cable in close proximity to the inner surface of MRI bore
3. Electrode characteristics - allergic reactions ,dry gel, improper contact with the skin, radiofrequency(RF) heating of the gel
4. Large patients
5. High power radiofrequency investigation requirement
6. Imaging of lumbar spine

In our patient, we presume some of the above factors may have played a role. Even when using MRI compatible monitoring system, attention has to be given to position of the cables (no loops), avoiding contact with skin and appropriate thermal insulation (between patient and RF coils).
