[SP-302] Look-Alike Oxygen Sensor Leads to Failed Calibration of Anesthesia Machine

[1] Dutoit A, [2] Tollette M, [2] Cure J, [1] de Armendi A
[1] The the University of Oklahoma Health Sciences Center , Oklahoma City , OK, USA; [2] The University of Oklahoma Health Sciences Center , Oklahoma City , OK, USA

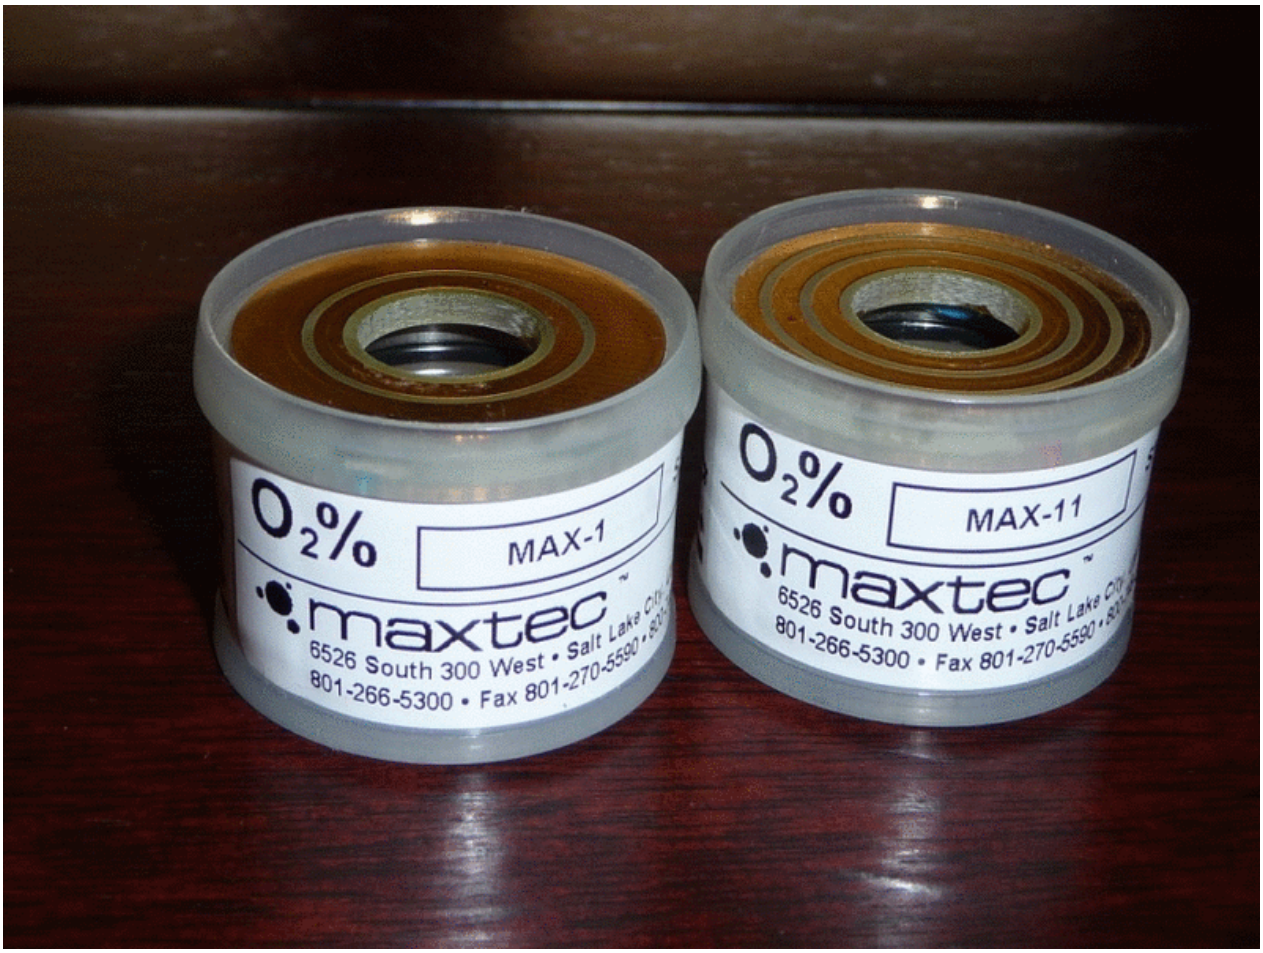
Medications and labels that look alike have led to potential or actual patient harm. Examples of this include those with epinephrine, heparin, and oxygen (1-4). We report a problem with the Maxtec MAX-1 and MAX-11 oxygen sensors which are commonly used on anesthesia machines (5). These oxygen sensors can be easily confused due to almost identical appearance and labeling (Figure).

During a routine pre-anesthesia machine check, the oxygen sensor was unable to be calibrated correctly. The anesthesiologist checked and re-checked the anesthesia machine to make sure that all of the replacement parts were properly installed and that the oxygen sensor and electrical components were properly connected, but calibration of the oxygen sensor was still unsuccessful. Anesthesia cases were delayed or switched to another area while the company responsible for the preventative maintenance of the anesthesia machine was called regarding the problem. A representative for the company was sent to evaluate the problem. On evaluation of the oxygen sensor, it was discovered that during a routine preventative maintenance check of the Dräger Fabius Tiro Anesthesia Workstation, a Maxtec MAX-11 oxygen sensor was incorrectly replaced with a Maxtec MAX-1 oxygen sensor. When the installed oxygen sensor was removed and replaced with the correct Maxtec MAX-11 oxygen sensor, the calibration of the oxygen sensor was successfully completed.

Similar labels and look-alike labels have caused problems and are a safety concern. We report the first case of the look-alike Maxtec oxygen sensor which prevented the calibration of the oxygen sensor on the anesthesia machine. This stresses the importance of the pre-anesthetic machine check including re-calibration of the oxygen sensor on a daily basis to ensure patient safety. We believe that anesthesia providers should be aware of these look-alike oxygen sensors and suggest that the Maxtec manufacturer address this problem.
